Manhole Inspection Summary

Manhole # S23GG1029MH

Insp Date: **3/15/07 1:58 PM**

Location Address: **1355 41ST ST**

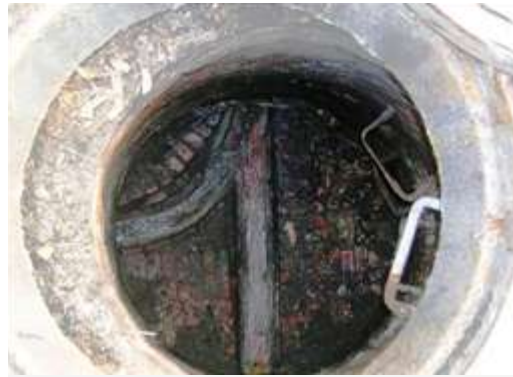
Top View

Corroded and missing steps. Evidence of surcharge - Bench debris.

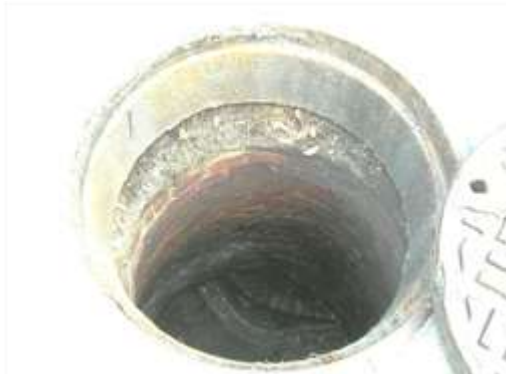
Defect

Frame leaks. Frame offset. Adjustment deterioration and infiltration. Corbel and Barrel infiltration.

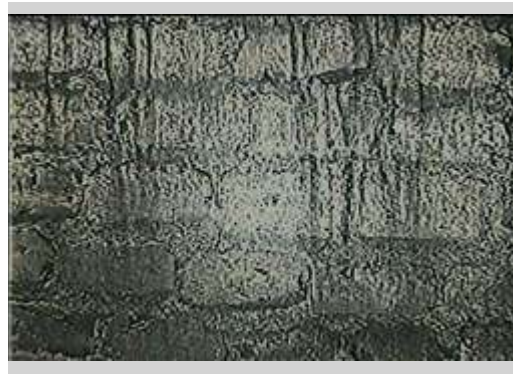
Defect

Barrel deterioration and infiltration.

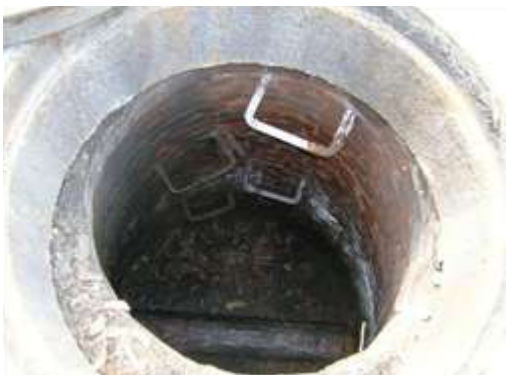
Defect

Frame leaks. Frame offset. Adjustment, Corbel and Barrel infiltration - other side.

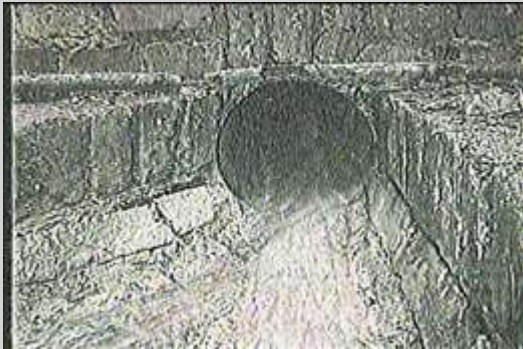
Pipe Out @ 12 O'Clock

Barrel deterioration and infiltration. Channel deterioration.

Infiltration: **Evidence** Pipe Seal Cond: **Cracked**

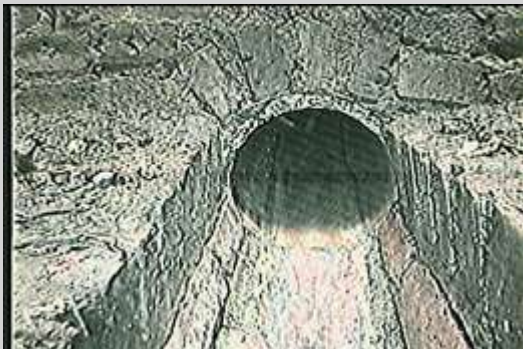
Pipe In @ 6 O'Clock

Barrel deterioration and infiltration. Channel deterioration.

Infiltration: **Evidence** Pipe Seal Cond: **Cracked**

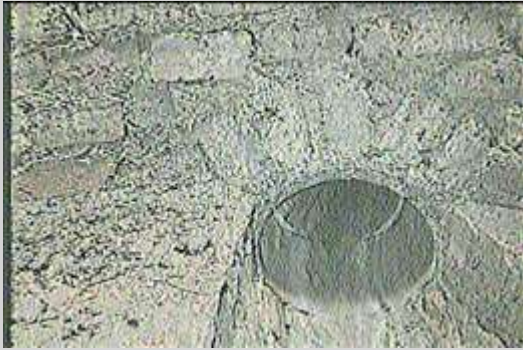
Pipe In @ 9 O'Clock

Infiltration: **Evidence**
